Evaluation of the compaction effects on the seismic stability of earth-fill dam – a case history -

Abstract: The main and auxiliary Fujinuma dams, Fukushima Prefecture, Japan, totally collapsed by the 2011 Off the Pacific Coast of Tohoku Earthquake (M9.0). The collapse was primarily due to poor compaction of the dam body while triggered by a prolonged strong seismic motion. The collapse mechanism of the main dam consisted of multiple sliding failures in the upstream and downstream slopes, which caused an overflow that eroded very fast the dam body, resulting in a total breach. This failure mechanism is successfully captured by numerical analysis consisting of a modified Newmark slip displacement method and a non-linear FEM, both taking into account the continuous deterioration of undrained stress-strain behaviour of the dam materials caused by undrained irregular cyclic excitation during seismic loading.

Collapse of Fujinuma dams, Fukushima Prefecture, Japan

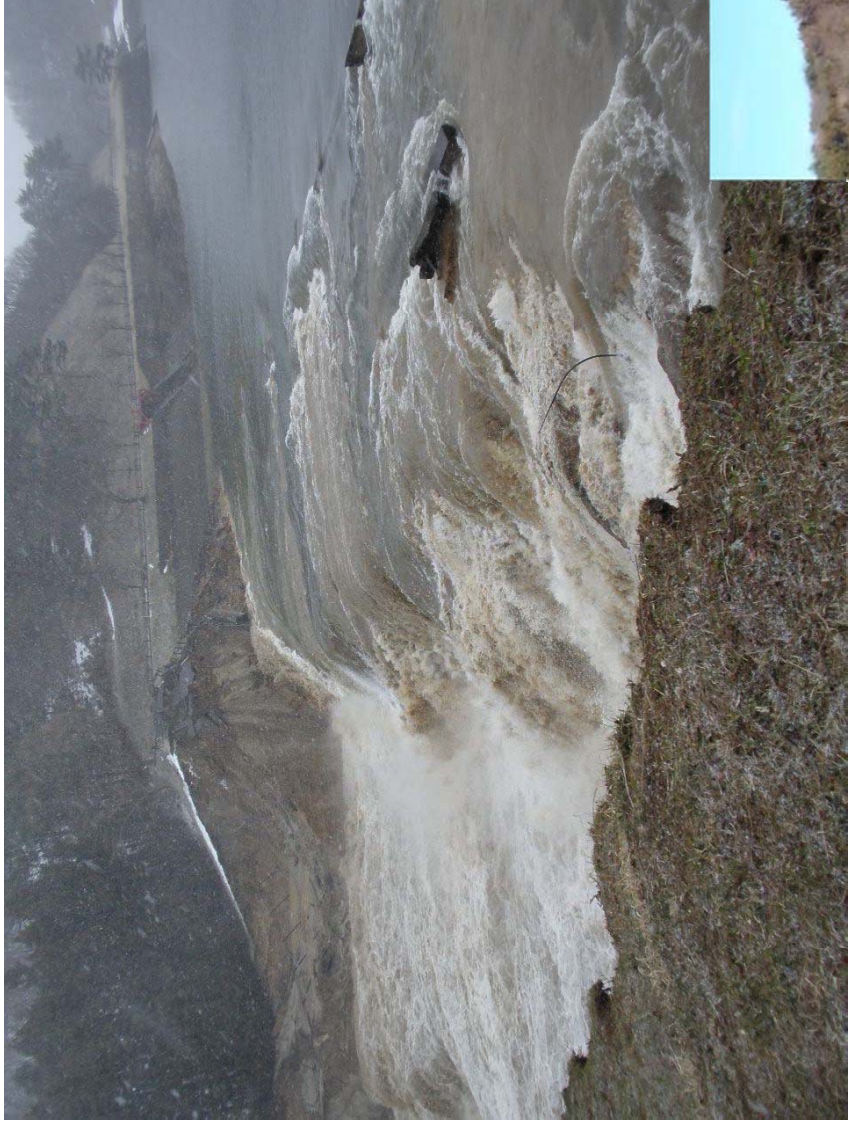
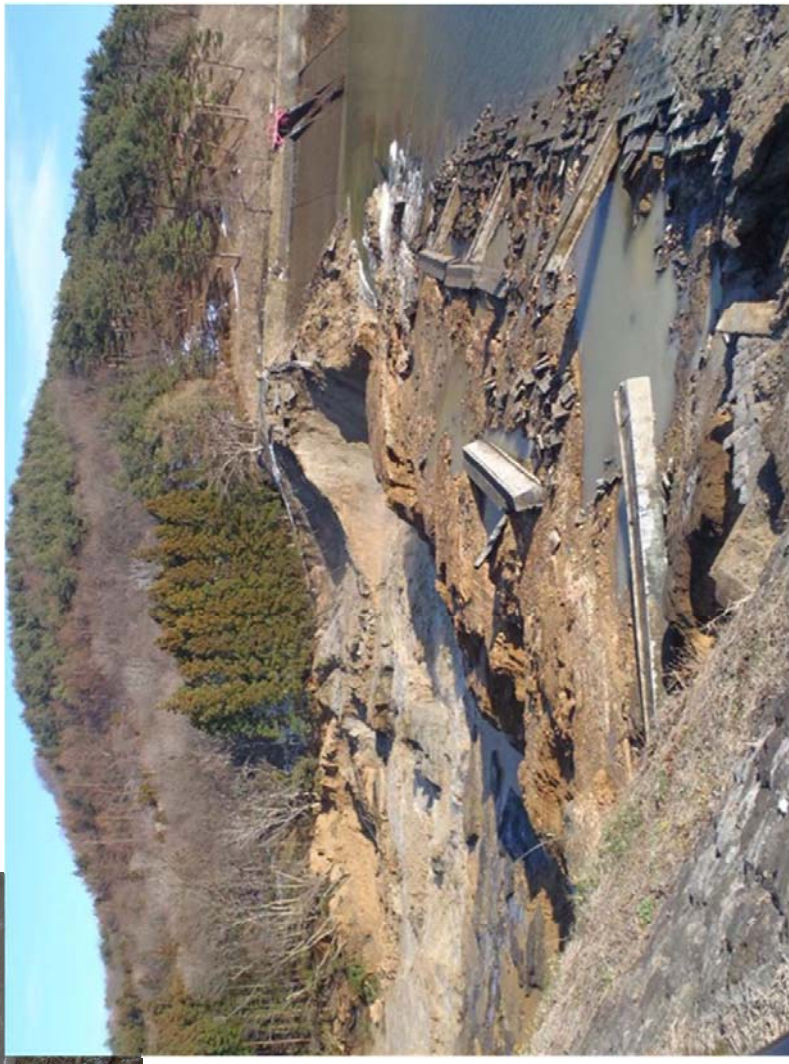
Main dam:
sliding failure resulted in
over-topping flow that
eroded the fill very fast.

Around one hour later

11 March 2011, PM 15:11,
immediately after the 2011 Great
East Japan Earthquake (PM
14:46:18, 11 March 2011)

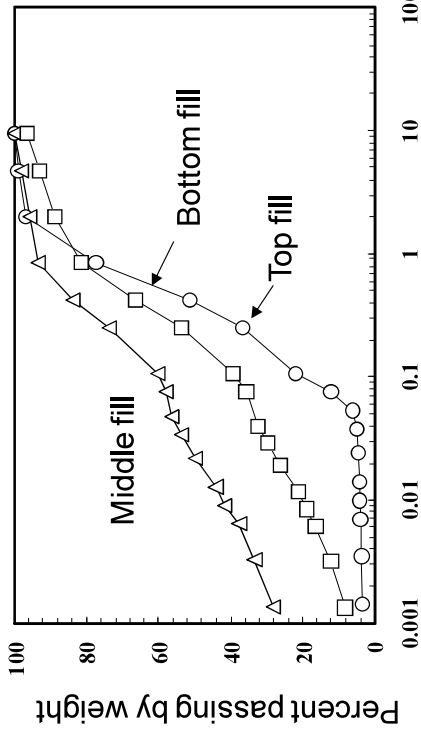
Main causes of collapse :
 Particularly poor compaction:
 very low $(D_c)_{1Ec}$ values
 Top fill: sandy soil compacted to
 $(D_c)_{1Ec} = 87.9\%$

a) the use of **sandy soil**, which is highly liquefiable when loose & saturated; highly permeable; and highly erodible;

b) very low $(D_c)_{1Ec}$

⇒ **low undrained strength, fast & large decrease by cyclic undrained loading**

→ start of failure unusually from the top fill, followed by larger failure in top & middle fills

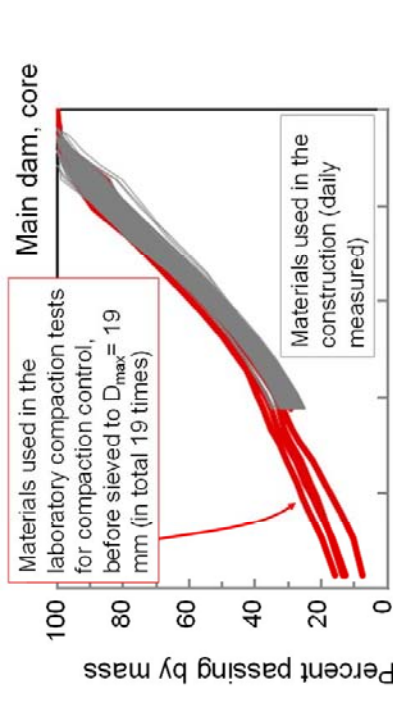
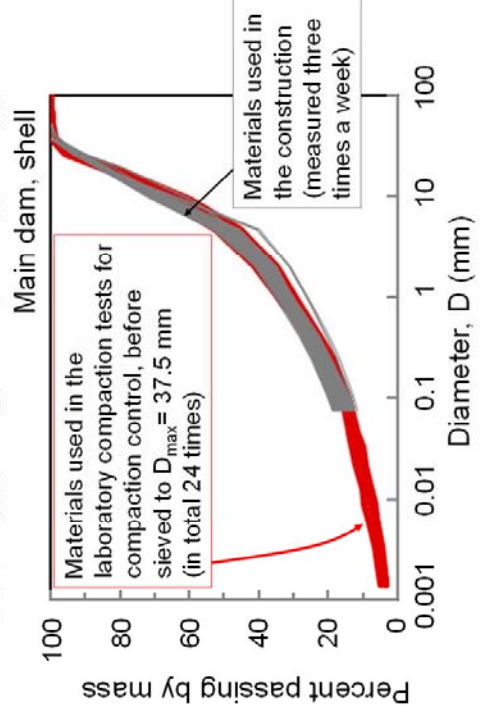
Adequate dam structure; and better fill materials for New Fujinuma dams

- The new dams were designed to be much more stable than the collapsed old dams, being sufficiently stable against the severe seismic load by which the old dams fully collapsed.
- ⇒ a modern dam structure; the use of better fill materials; and better compaction by controlling not only dry density & water content but also the degree of saturation.

New Fujinuma dams

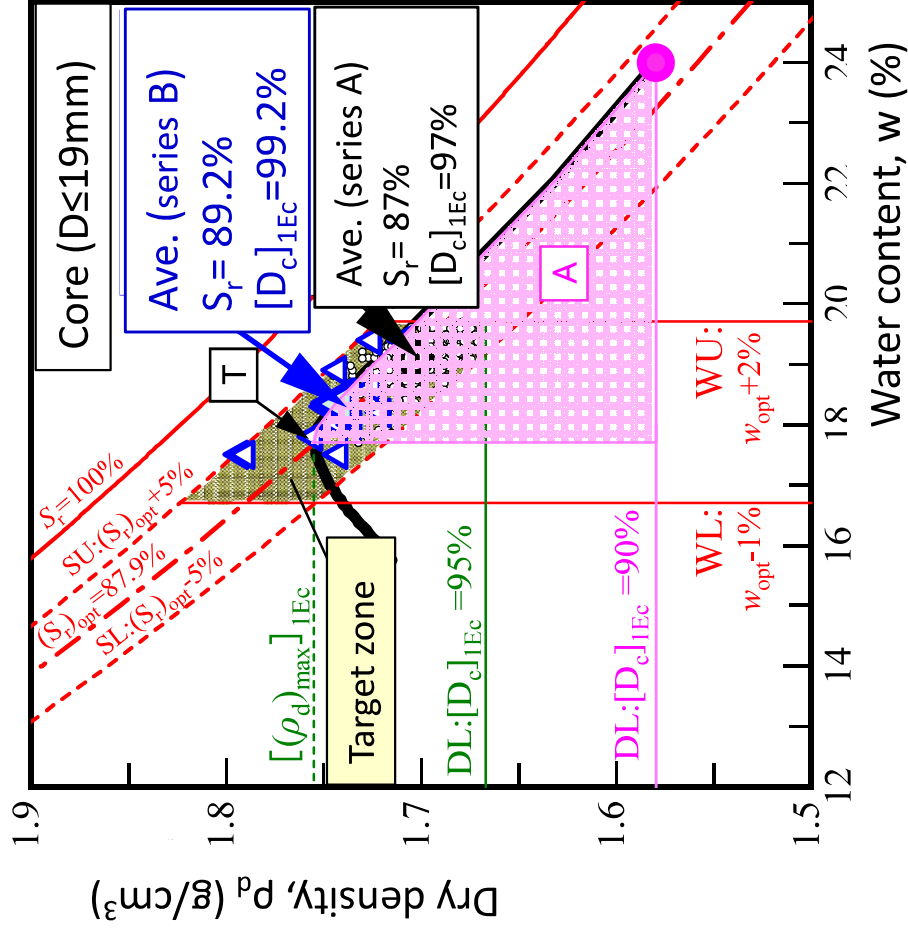
Conventional design/construction code for irrigation dams (effective at the time of the design and construction of new Fujinuma dam):

A: Target zone of acceptance, allowable lower bound of $[D_c]_{1EC} = 90\%$

●: Compacted state where the design strength/stiffness is determined.

⇒ leading to ineffective compaction at too high w values

In the construction of new Fujinuma dam, by the new compaction control, satisfactory compacted states at higher $[D_c]_{1EC}$ & lower w around target T.

At target T, $[D_c]_{1EC} = 100\%$ & $S_r = (S_r)_{opt}$ are realized cost-effectively.

⇒ Subsequently to this project, the design/construction code was revised introducing the structure of this new compaction control.

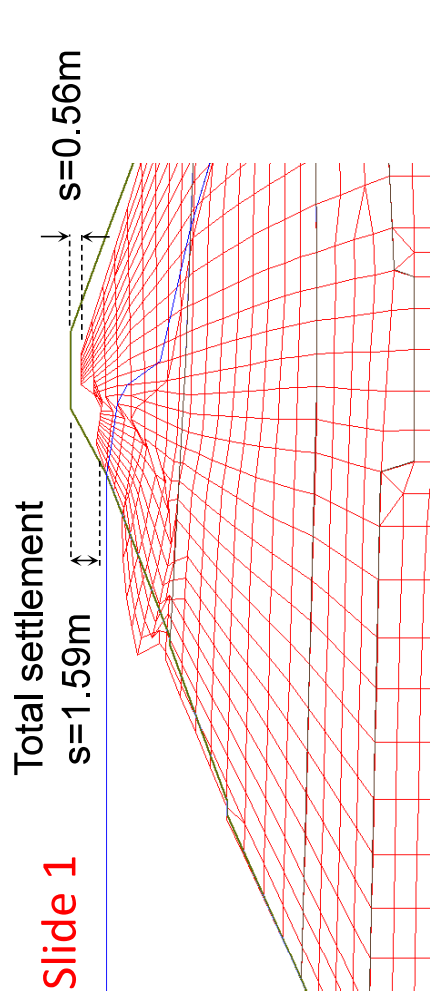
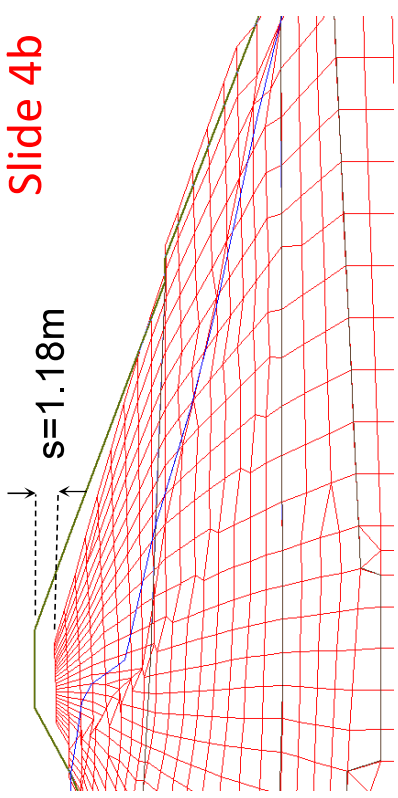
Combined displacements by Newmark-D + 2D pseudo-static FEM

Slide 4

Slide 1

Slide 4b

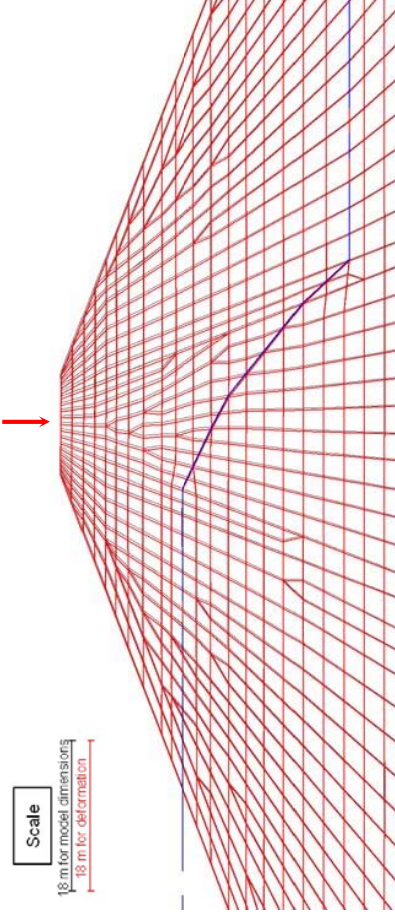
Analysis of residual continuous deformation by pseudo-static non-linear FEM analysis (based on deteriorating undrained properties)

- Measurement: no discernible residual displacement at the dam crest

- Analysis: only a very small settlement computed at the dam crest

s = 0.9cm : average settlement at crest

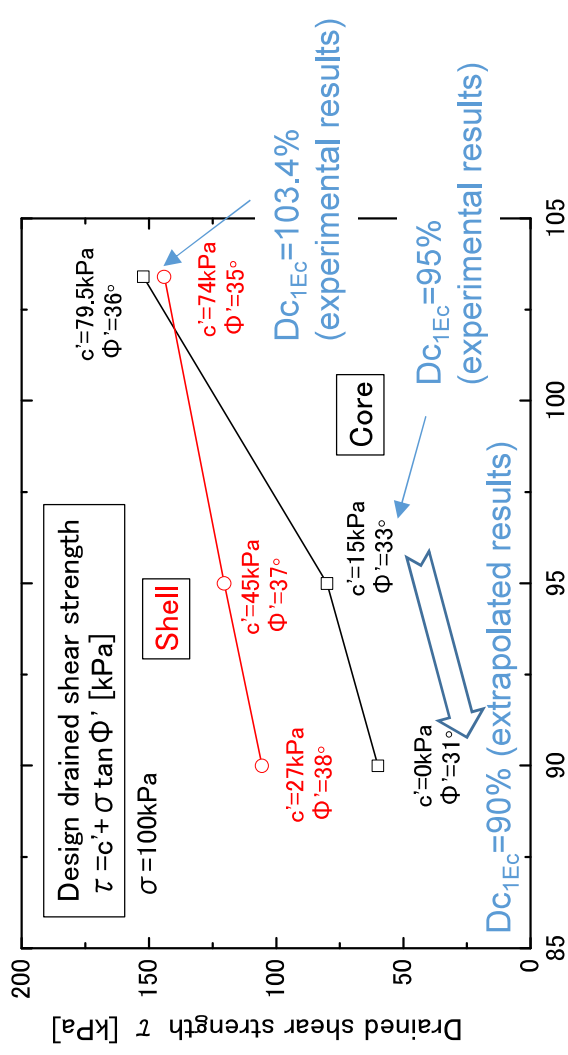
Seismic stability analysis using design drained shear strengths

- Drained shear strengths of the dam materials compacted to

a) $Dc_{1Ec}=95\%$ (current design code for agricultural earth-fill dams in Japan) and estimated for

b) $Dc_{1Ec}=90\%$ (previous design code) by extrapolating existing data

⇒ The dam stability is unduly underestimated, in particular in case b), unlike Newmark-D method

- Factor of safety F_s for slips showing the minimum F_s during earthquake

*slip location slightly differ for each Dc
